SUBJECT John Anglin, Clarence Anglin and
Frank Lee Morris Escape from Alcatraz

FILE NUMBER 76-26295

VOLUME NUMBER Enclosures 76, 137, 155 and 179

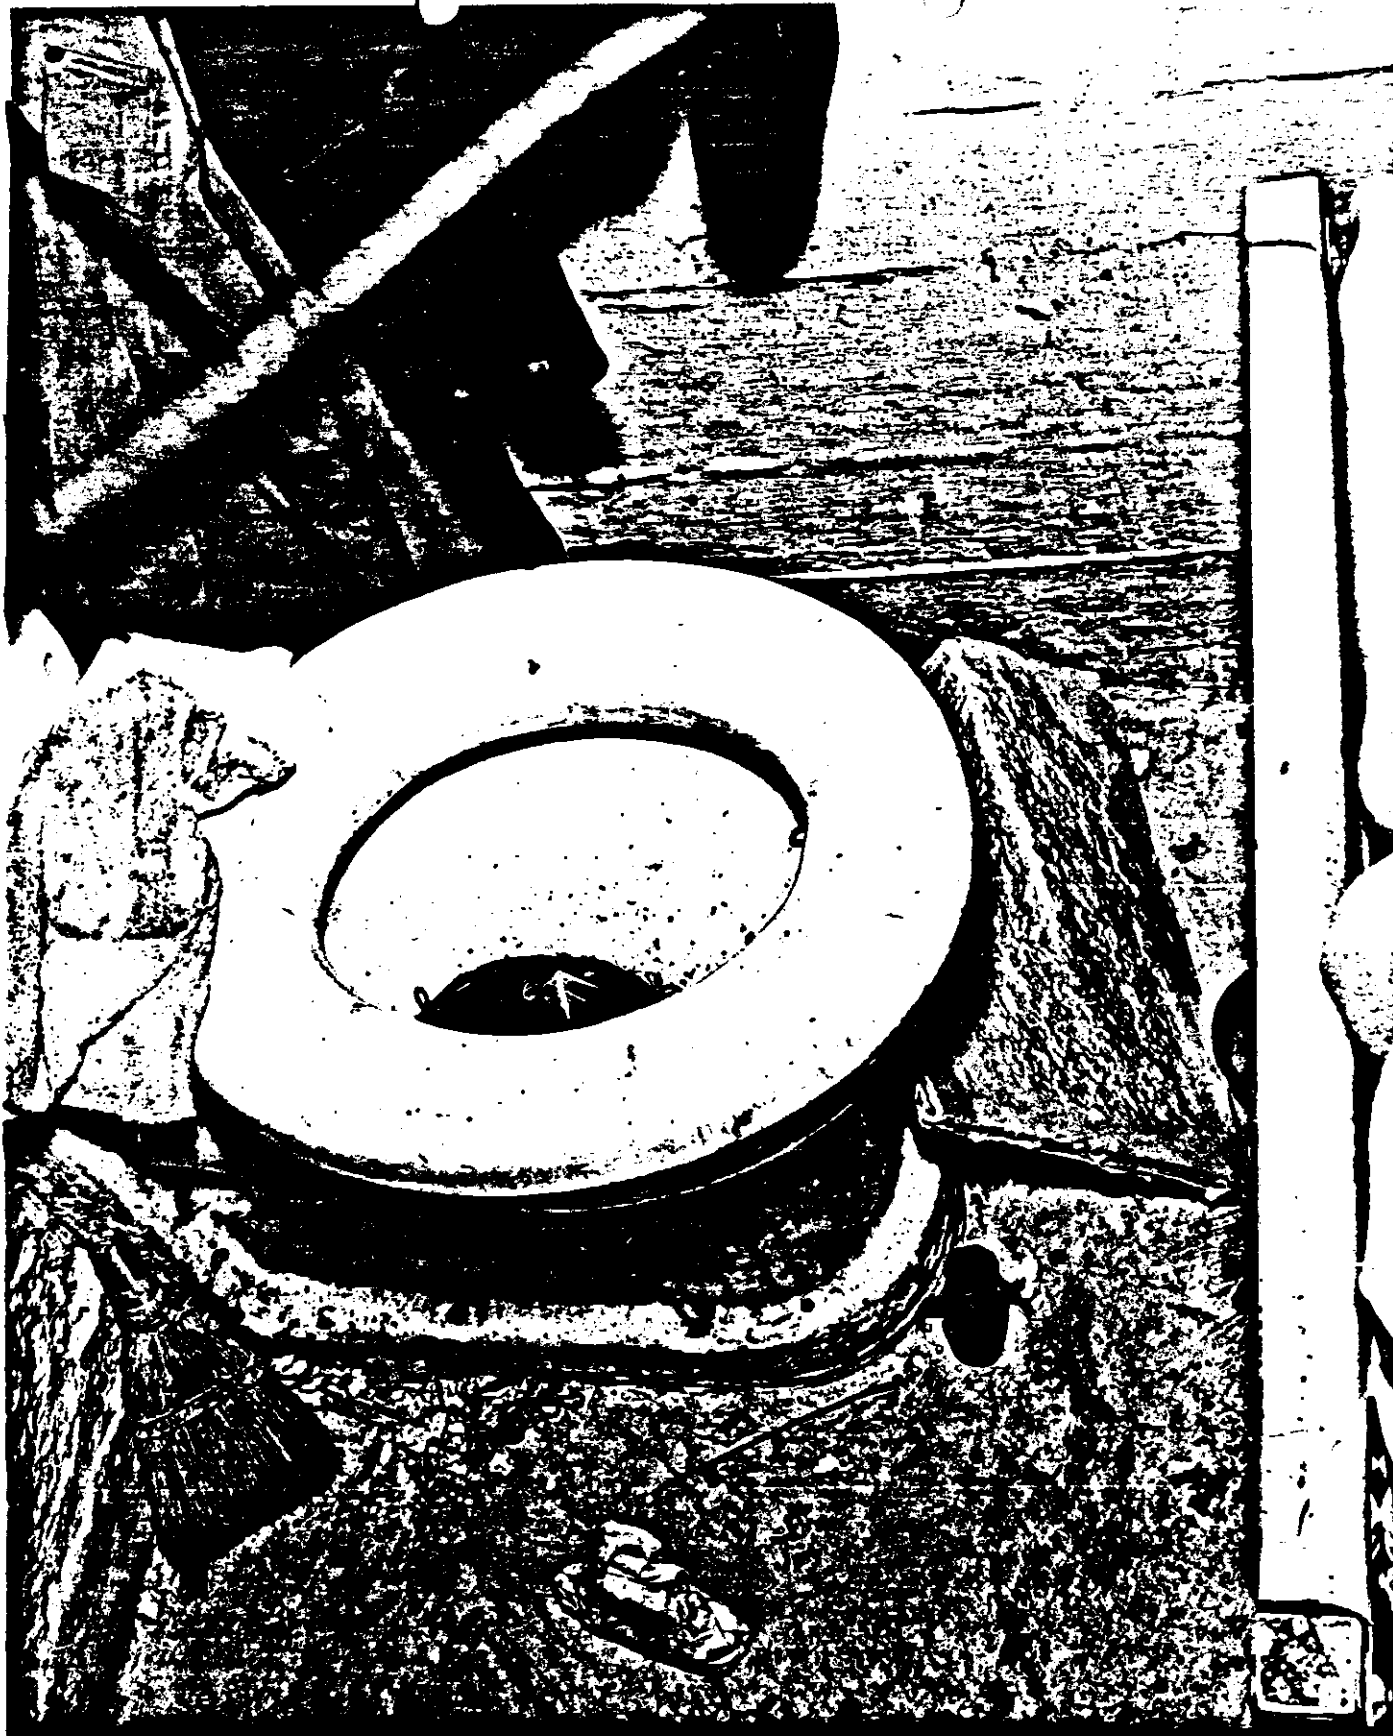
3-4

Photograph taken in the cell of CLARENCE ANGLIN showing detail of toilet facility at foot of bed. Portions of soap scraps and plaster are visible as are fragments of hair. Immediately forward of the toilet seat is a portion of the grill made by Subjects to replace that removed from the cell. The portion of the small circular object seen is the cup which is supplied to prisoners for shaving purposes. This cup contained water and a brush.

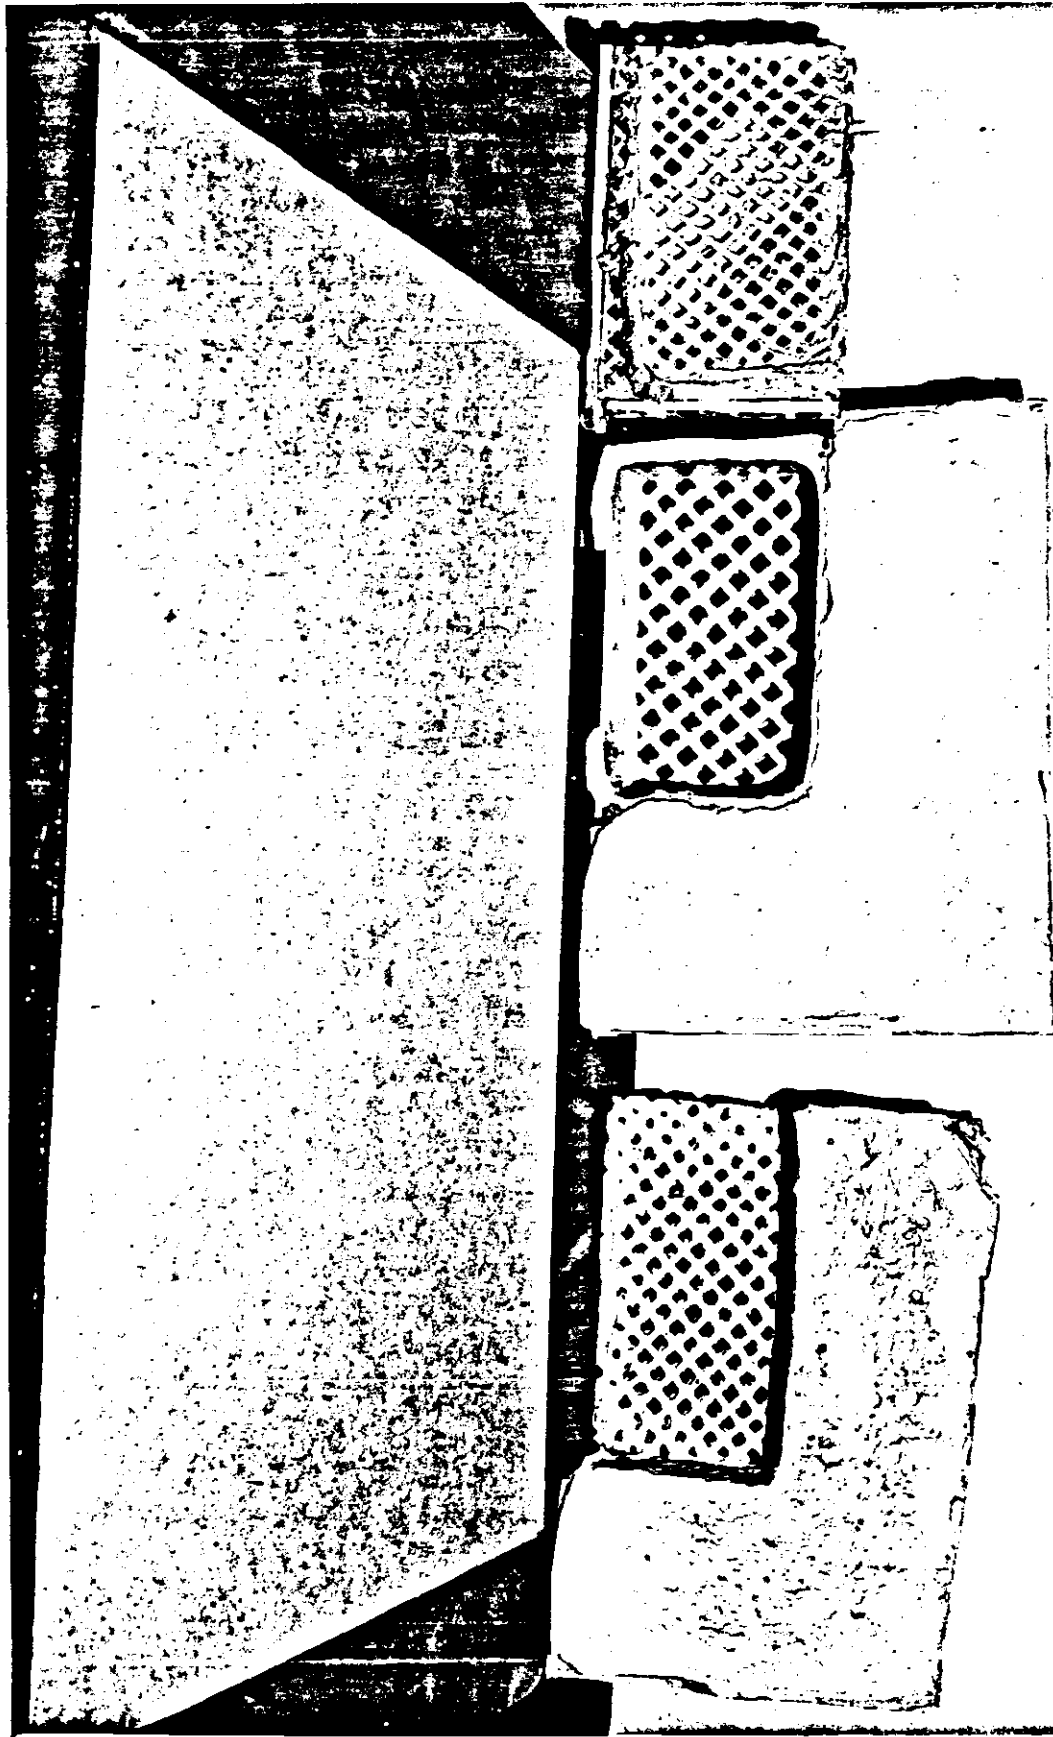
Replicas of ventilator grills placed in openings in cells through which Subjects exited to utility area between cell blocks B and A. Replica on the left is the actual size of the metal grill originally in the wall; it was reproduced, as were all the rest, from artist's drawing board which was faced with a linen-type substance. This material is available to all inmates for art painting purposes.

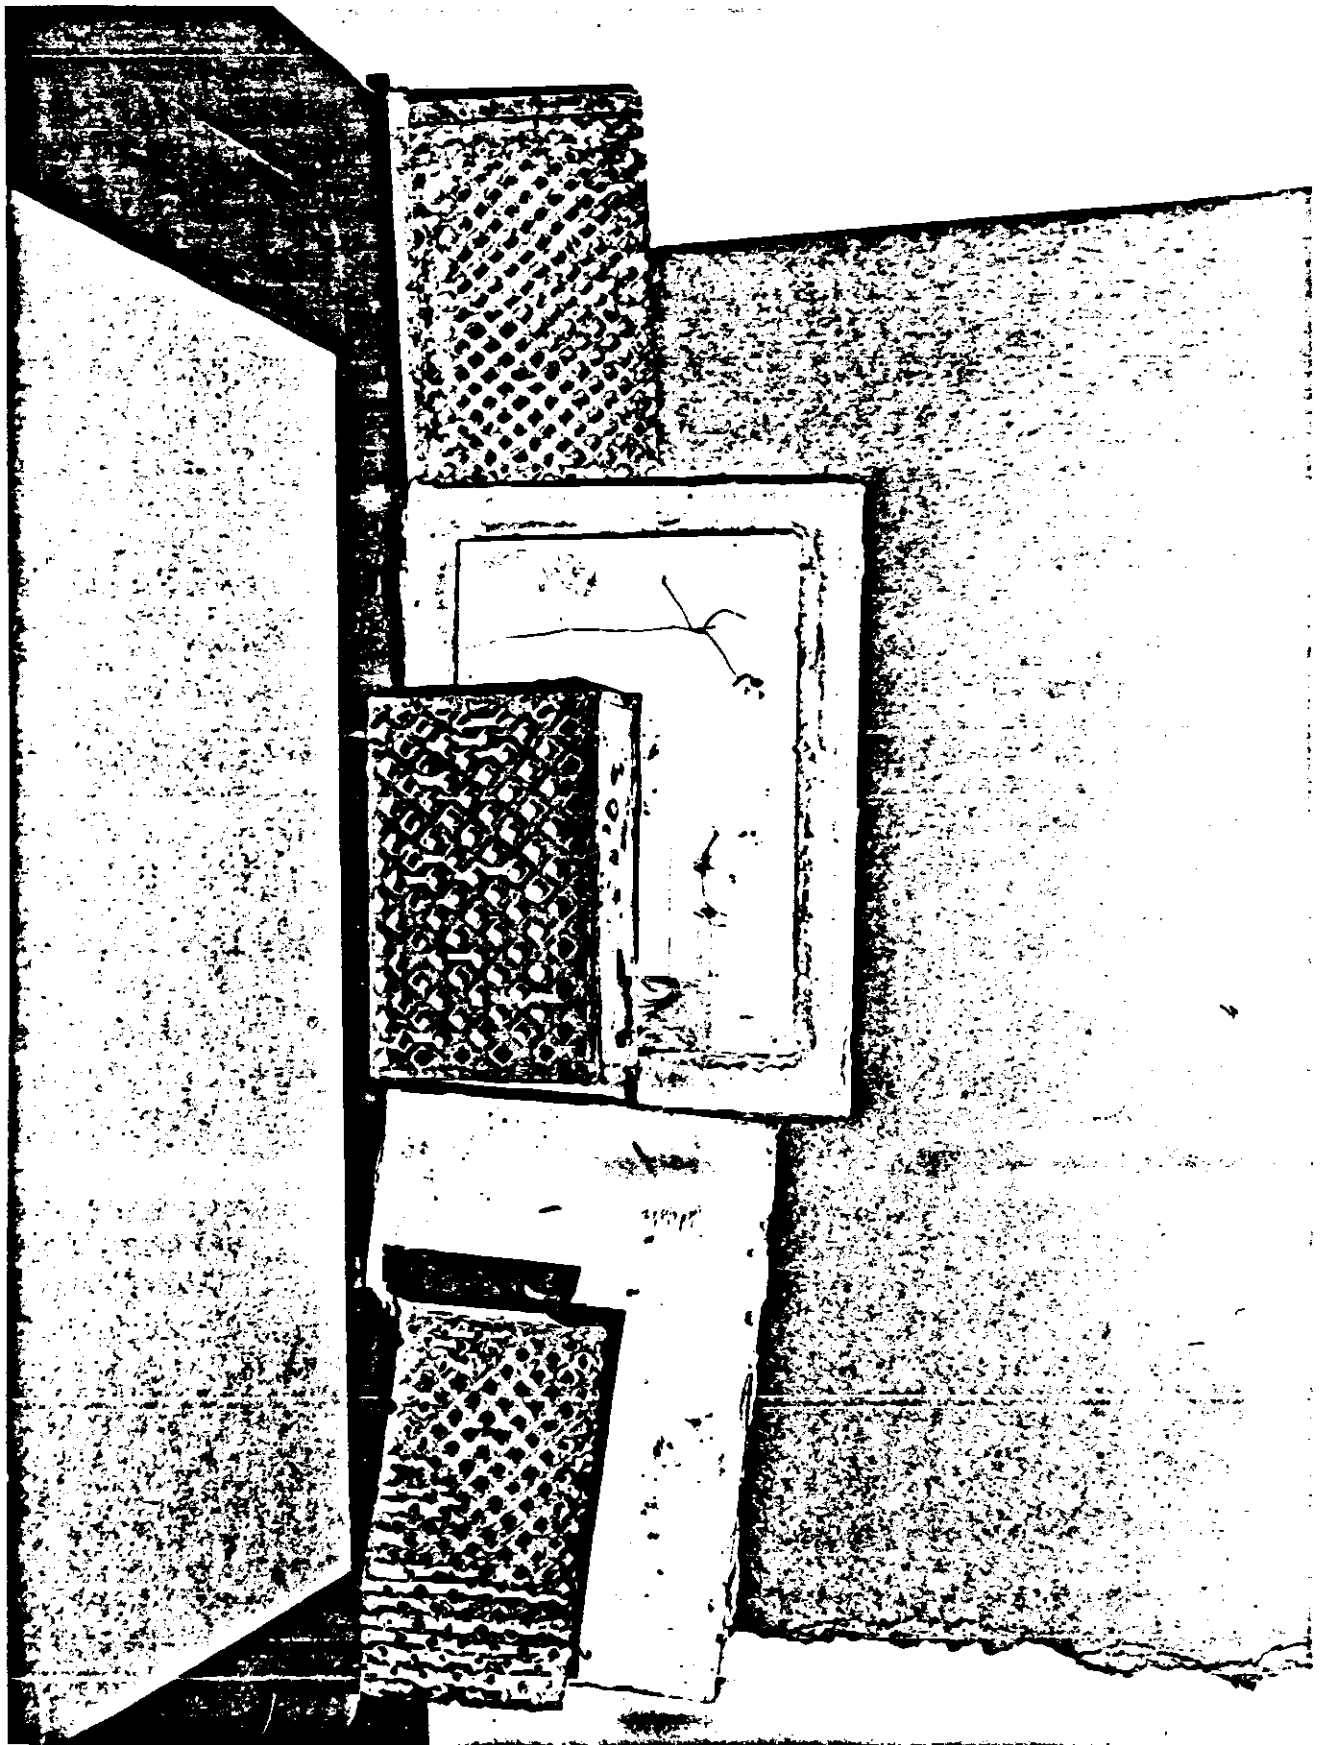
Rear view of three replicas of ventilator grills used by Subjects to replace original grills in their three cells. Note wire hooks by which grill and surrounding surface could be pulled into place after Subject's exit into the utility area.

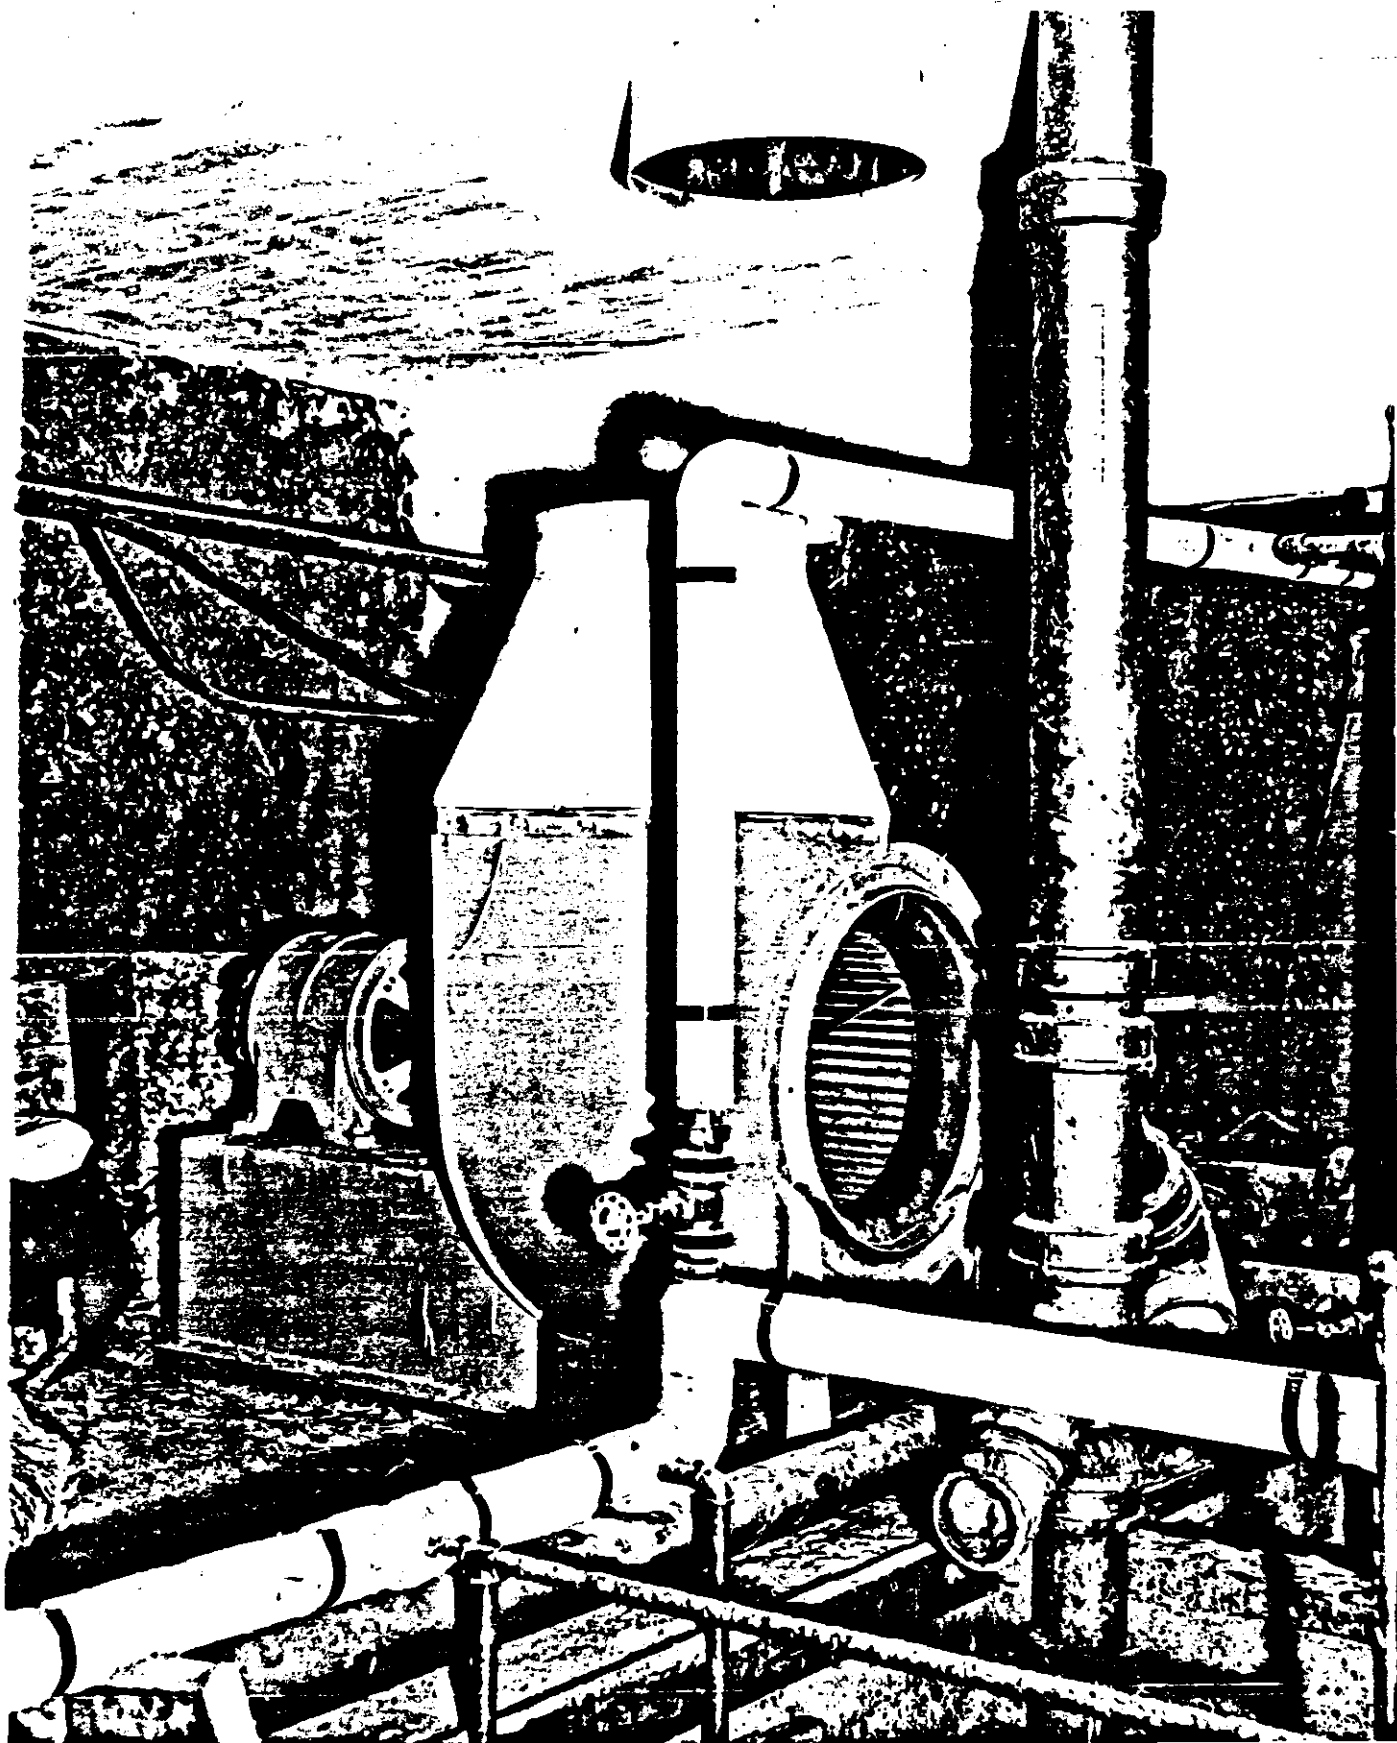
3-10 Photograph taken of the abandoned ventilating fan with opening through to the roof. Left rear and center background shows the manner in which this area was completely enclosed by drop cloths and blankets hung ostensibly to prevent splattering of paint into the cell block.

It was in this ventilator that the abandoned pantoon and two bundles of raincoats were located. Articles at the bottom of this ventilator could be reached by a long pole which had a nail protruding and could be used as a hook.

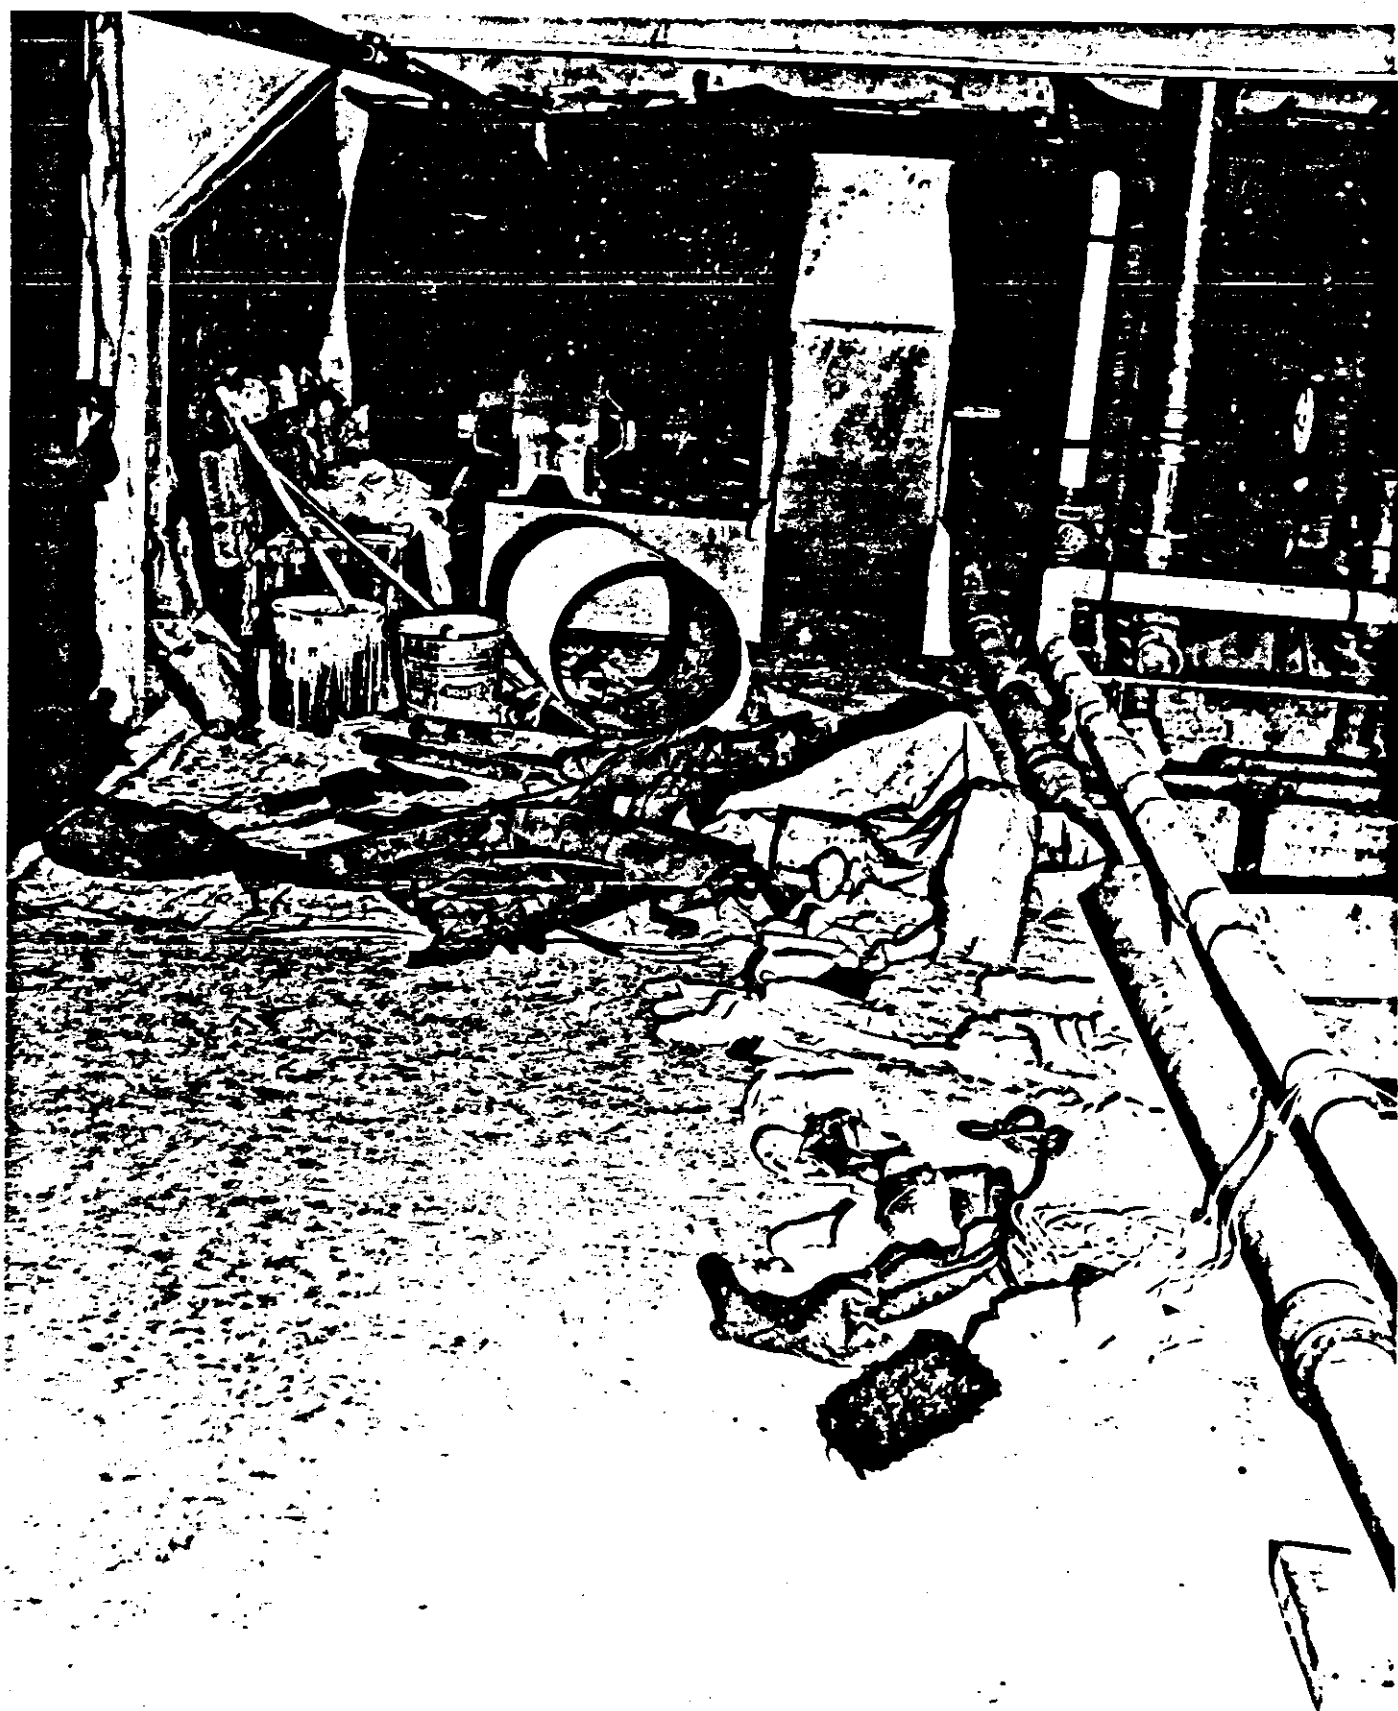
3-11 A general view looking toward the end of Cell Block B. The portion of the blanketed grill wall seen across the upper portion of the picture was across the end of the cell block. Approximately directly opposite the large black cast iron vent seen in upper right and down on the main floor was the main entrance to the entire cell area. The blanketed or screened-in area covered an area approximately thirty to thirty-five feet in length from the end of the cell block and extending on both sides, giving perfect concealment.

At lower right center may be seen a white cord which was tied to the hot water pipe crossing between Cell Block B and C and was one inch in diameter. This cord was lowered down the utility shaft and upon reaching the bottom, which was directly behind Subject's cells, it was determined to be twenty-six feet ten inches. Sections of this cord were knotted at intervals which apparently indicated the tier level reached when lowering or raising the rope. Fragments of raincoat material may be observed in general debris in center of picture. The five-gallon paint bucket from which a stick is seen protruding contained hardened cement paint and it was in this bucket a number of the Subjects' tools were subsequently located.

The heavy plank extending across the chair may have been used as the weight necessary when "vulcanizing" the seams on the raft and "Mae West" jacket.

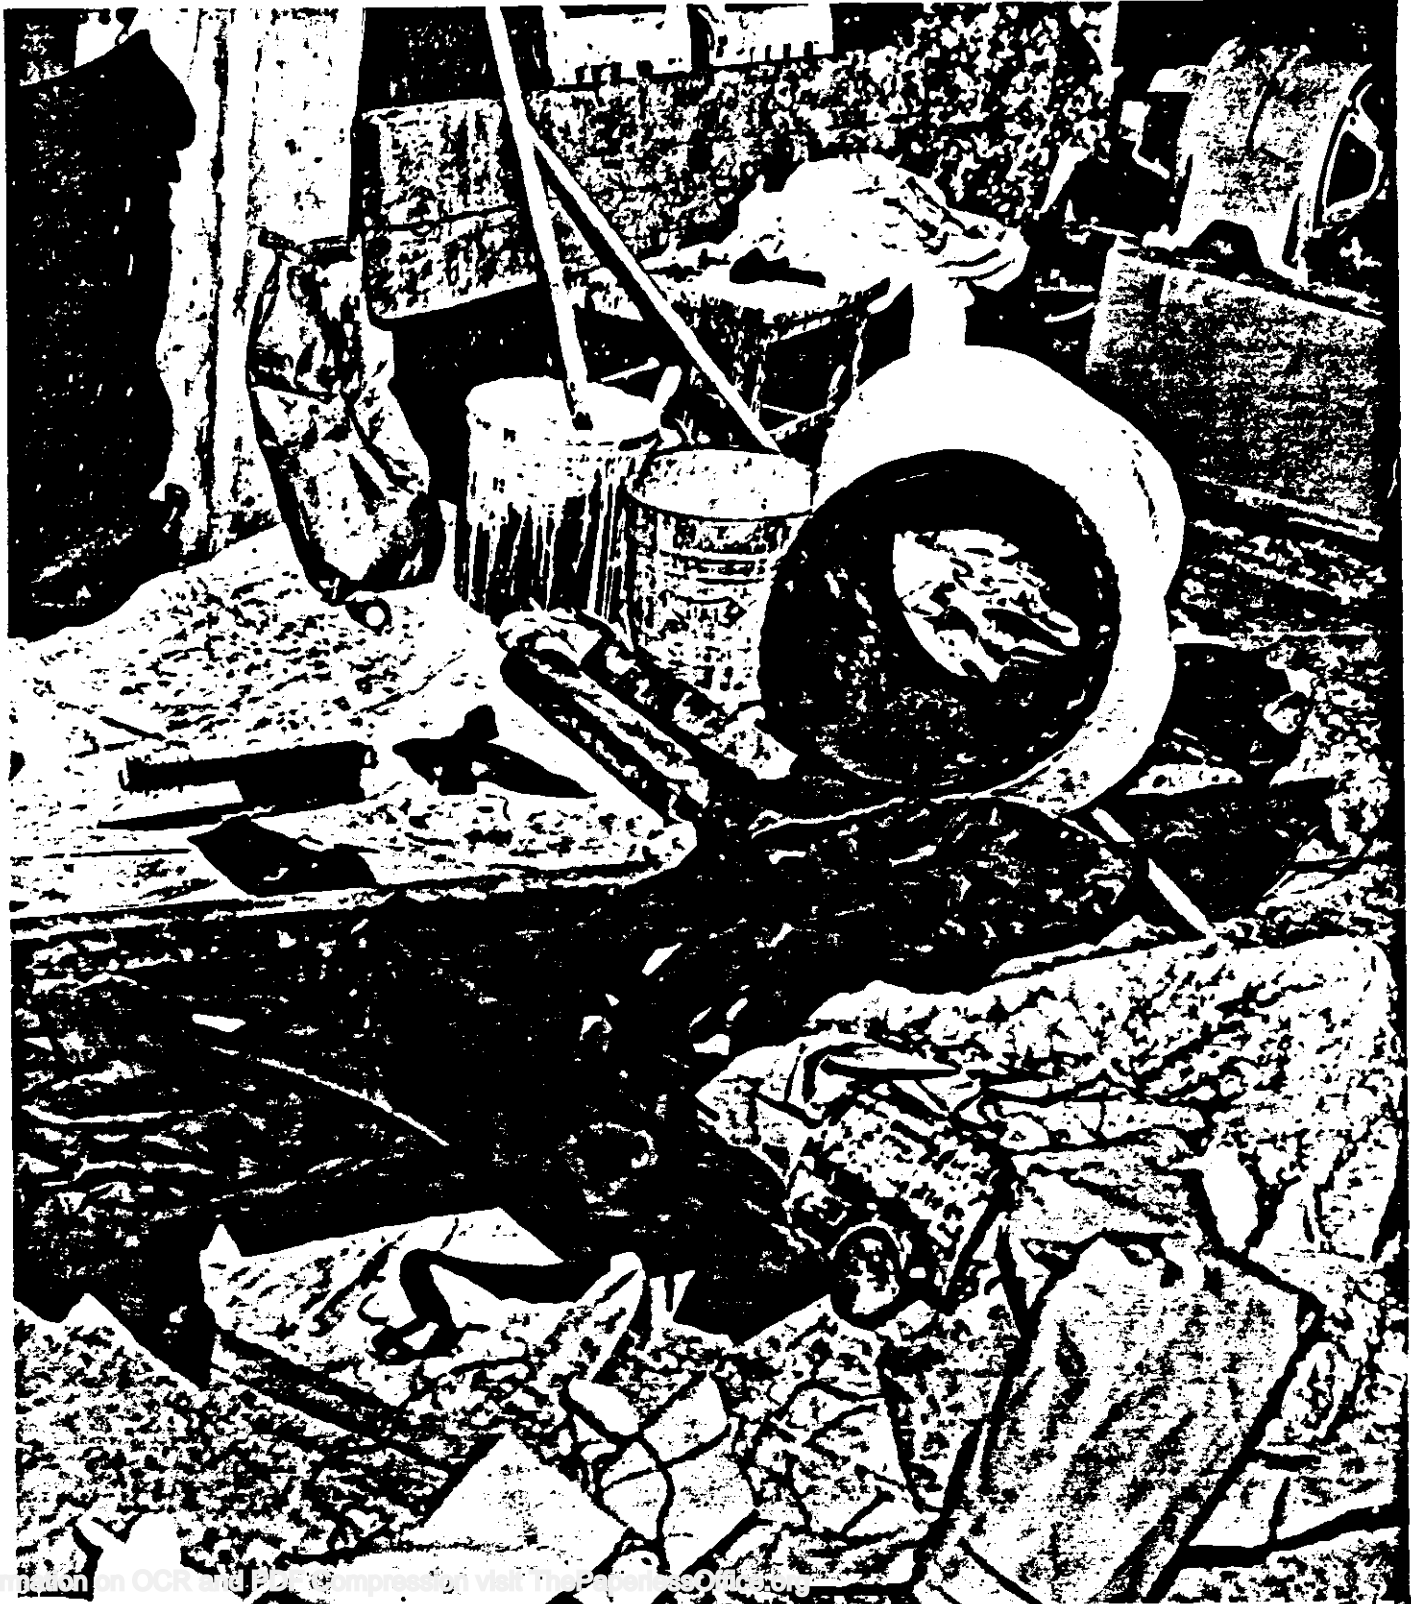
- 3-12 General view taken approximately fifteen feet from the bucket seen in center foreground. Lower left center are pieces of white Navy blanket cut in strips. The material seen at lower right is a type believed to have been used in making the raft. The goosenecked connector from the ventilating motor to the roof is seen in upper right. On the chair may be seen the remains of some brass bolts which were either machine or electrical bolts and brass washers and nuts identical to those found in the paddle.

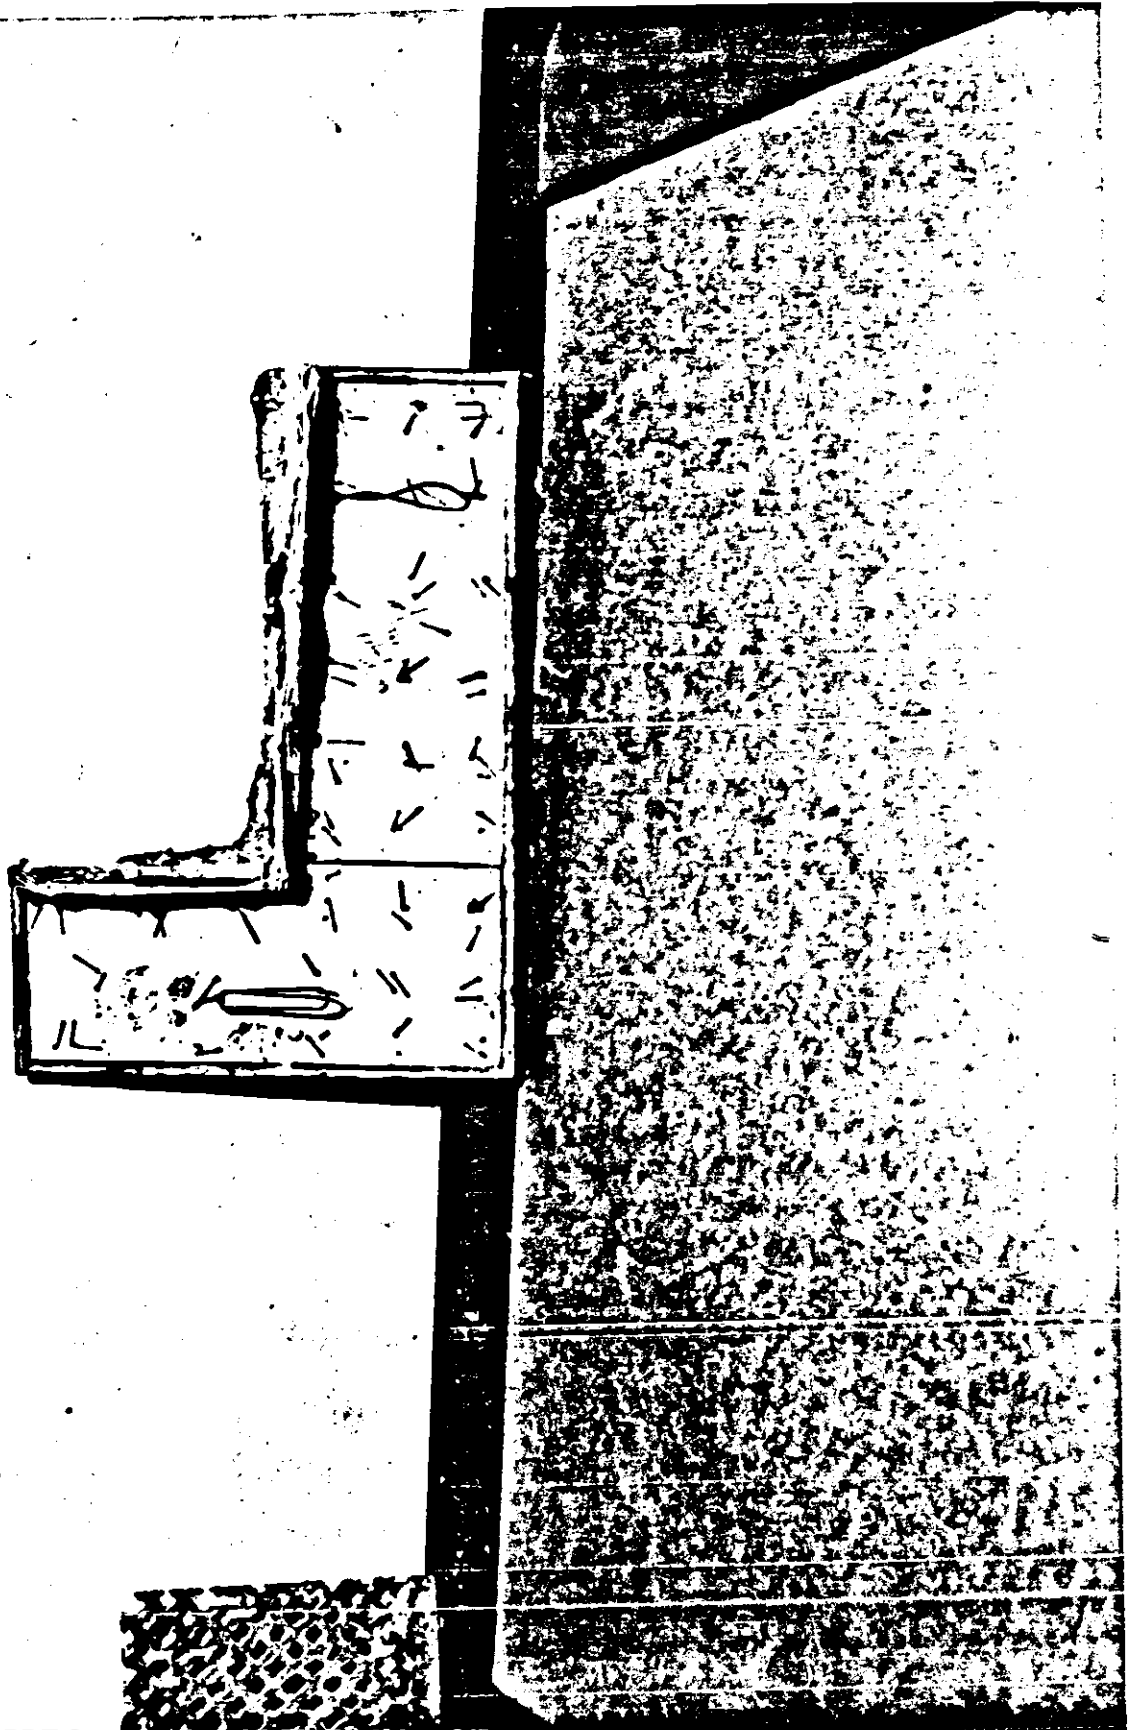
Rear view of concrete replica showing hard board. Note the wire hooks which were used to draw the replica into place from the inside of the cell.
